Devil's Slide/Hwy 1 Storm Repair

Daily Updates from Bijan Sartipi

Daily Update
June 19

Devil's Slide (post mile 39.14)

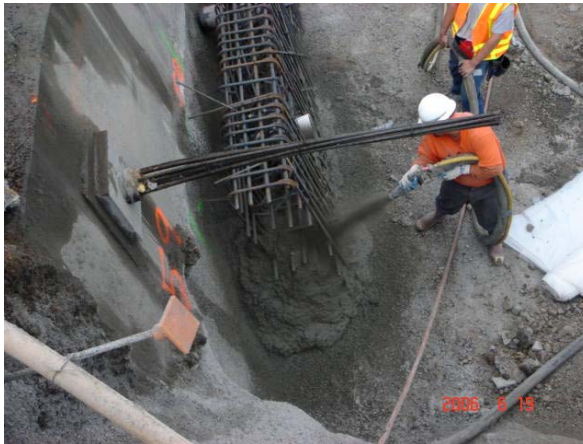
- Whaler (bracing) wall construction:
Whaler wall 'A' (upper level ocean side) – complete.
Whaler wall 'B' (lower level ocean side) – shotcreting began at the south end of the wall.

Shotcrete work starts on south end of wall B

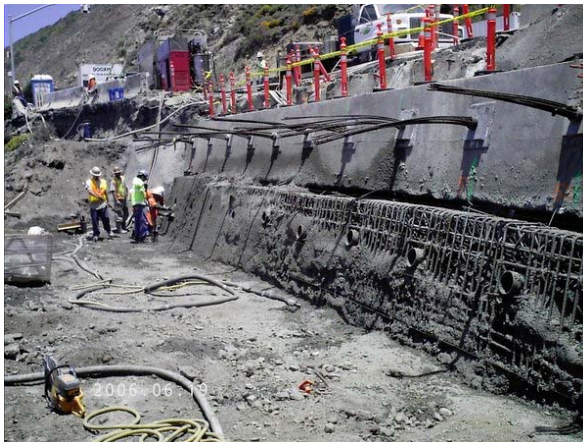
Shotcrete south end of wall B

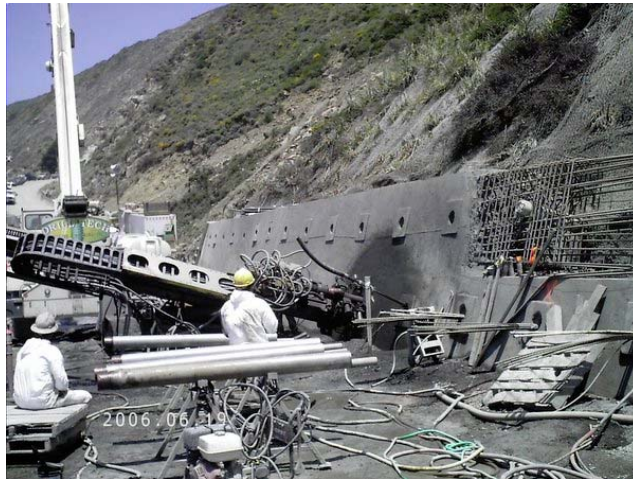
Whaler wall 'C' – drilling continued. 22 out of 34 tiebacks installed.

Drilling tie backs at wall C
